AMAWALK DAM

WESTCHESTER COUNTY, NEW YORK

INVENTORY NO. 45

**PHASE I INSPECTION REPORT
NATIONAL DAM SAFETY PROGRAM**

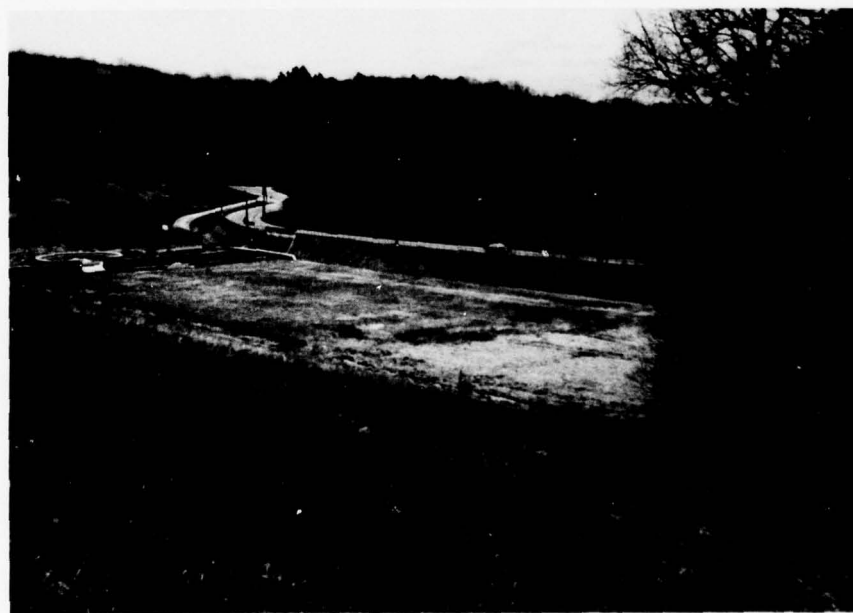
(B) The toe ditch on the right side of embankment contains debris, loose deposits and vegetation growth.

DOWNSTREAM SLOPE, TOE DITCH, RIGHT ABUTMENT CONTACT
SHOWING THE AREA OF SEEPAGE [OBSERVATIONS (A), (B) AND (C)]

a. The results of the additional investigations recommended in Paragraph 7.1d may indicate a need for corrective measures in connection with the seepage conditions which were observed at locations (A), (C), (I), (J), (O) and are described in Paragraph 3.1. Recommendations concerning possible corrective measures can only be made after the completion of the additional investigations.

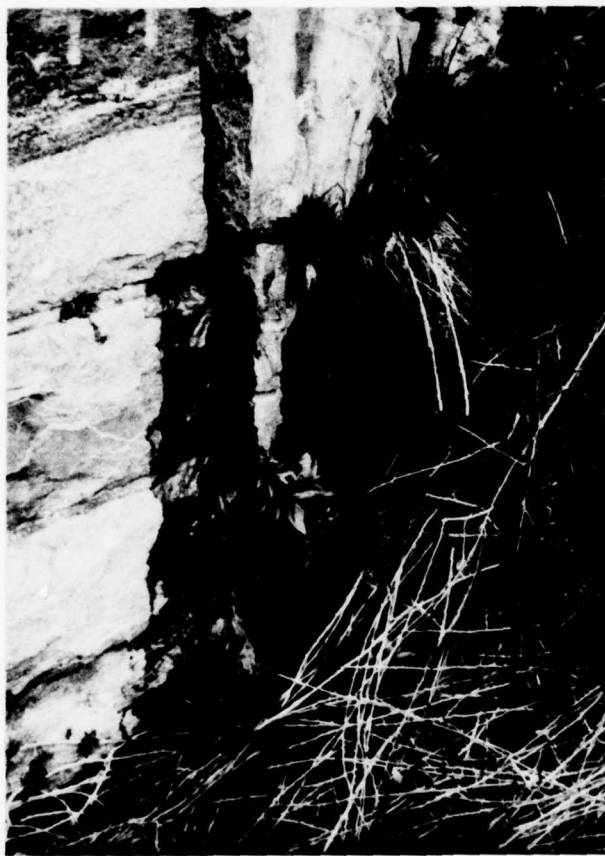
(Q) The stone wall left of the gate chamber has moved about 3-inches downstream and 2-inches vertically downward along a construction joint. This movement appears to be the result of inadequate surface drainage mentioned in (H).

DETAIL OF WALL JOINT LEFT OF GATEHOUSE WHERE MOVEMENT
AND SEEPAGE WAS NOTED. [OBSERVATIONS (I) AND (Q)]

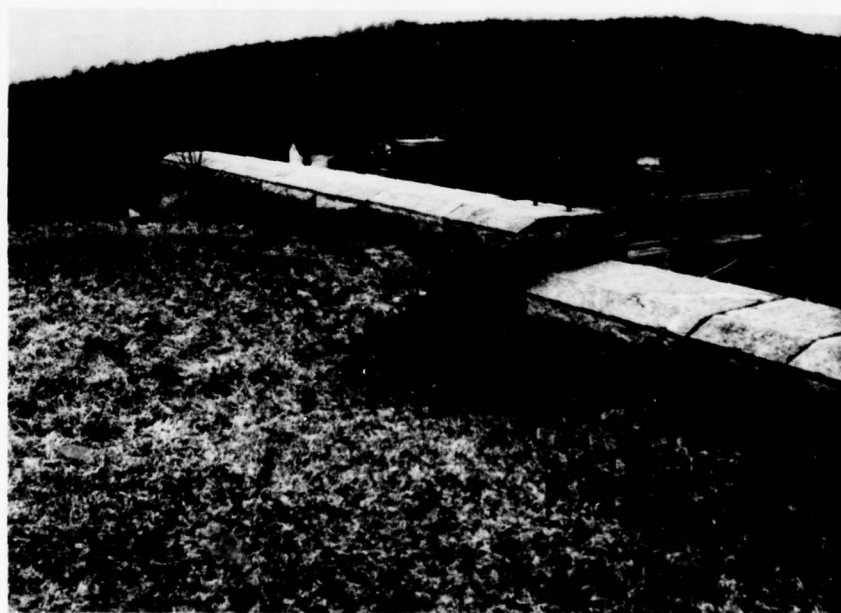
(D) Surface erosion was noted on the crest on both sides of the spillway wall.

EROSION ON CREST AT SPILLWAY WALL [OBSERVATION (D)]
(THE STEP IN THE WALL IS NOT MOVEMENT)

Most of the conditions covered by Items (B) (D) (E) (F) (G) (L) and (N) can be handled as part of the maintenance work.

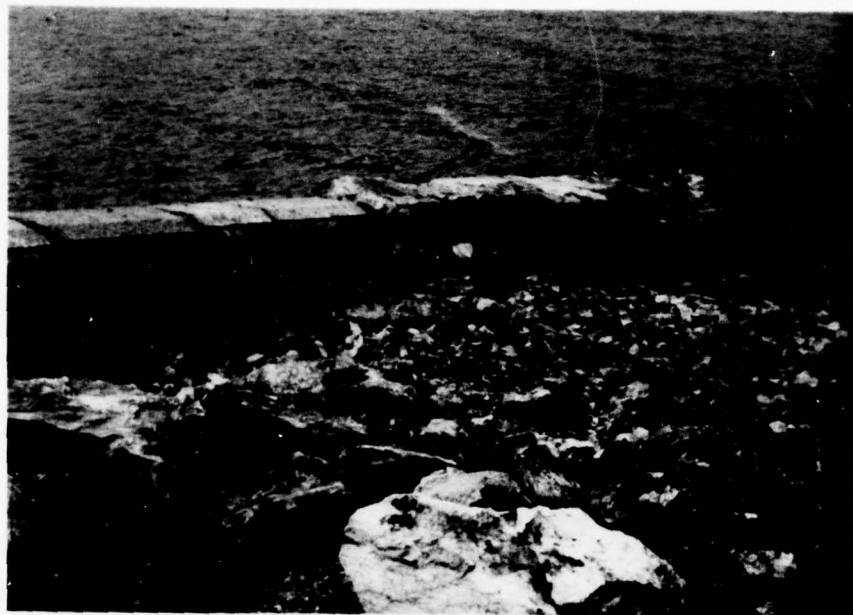
(F) There is some damage to the riprap near the left spillway wall.

(L) Both spillway inlet walls at reservoir level are in damaged condition; large stones comprising the masonry wall are loose and/or dislocated.

RIP-RAP AND SPILLWAY WALL DAMAGES [OBSERVATIONS (F) AND (L)]

* Upstream ends of both inlet walls are damaged
Looking upstream, a large block of masonry on
the left side wall has been dislodged. The alignment on
the right side has been somewhat altered

f. The damage to the spillway walls should be repaired. The movements of the spillway chute walls will probably stop after the downstream drainage improvements have been carried out.

g. Minor riprap damage should be corrected. The small size riprap on the main embankment is subject to damage by major storms. An inspection, and, if needed, corrective work should be carried out after such storms. The riprap on the auxiliary dam is considerably heavier than that on the main dam; there are some depressions, however, in this riprap which require some maintenance work.
